# CONDUCTOR REPAIR CLAMP

PRODUCT GROUP  
**MORGRIP CLAMPS  
& CONNECTORS**

## PRODUCT DESCRIPTION

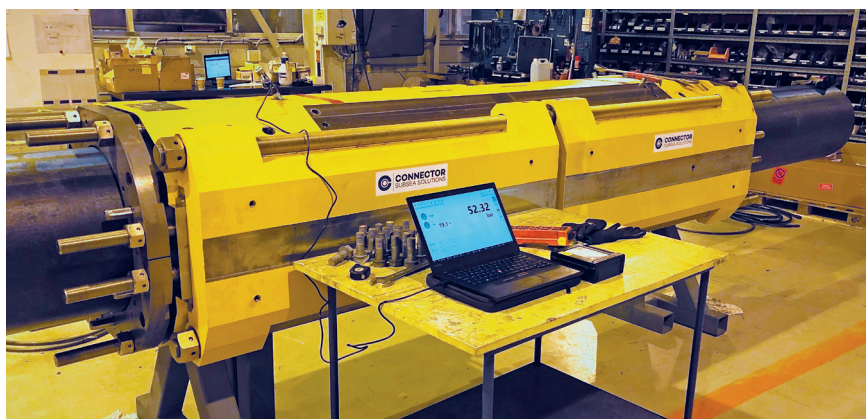
01 // Conductor clamp pressure testing

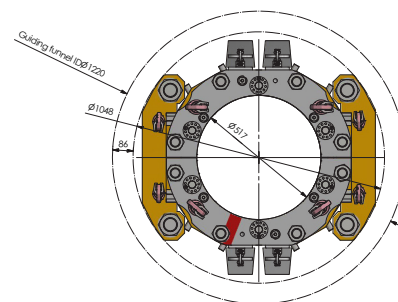
Guide funnel space envelope

The conductor repair clamp is specifically developed for repair of conductors with damage in the guide funnels. This can frequently occur due to damaged and broken centralisers. Repair within the guide funnel is particularly challenging due to the restricted access that prevents the use of standard clamps with longitudinal bolting.

Using our patented C-Bar activation, our conductor repair clamp mitigates the need for longitudinal bolting to ensure a fit within the guide tunnel. Activation via the top or bottom enables fast, easy and safe access.

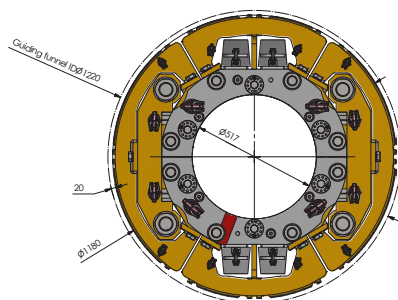
Clamp within guide funnel complete with centralizers

Including a structural and a sealing element, the clamp can take the full structural load of the conductor and prevent leaks from occurring. Delivered with custom centralizers mounted on the body to reinstate the centralizing function, the clamp addresses the potential root cause of the original failure.

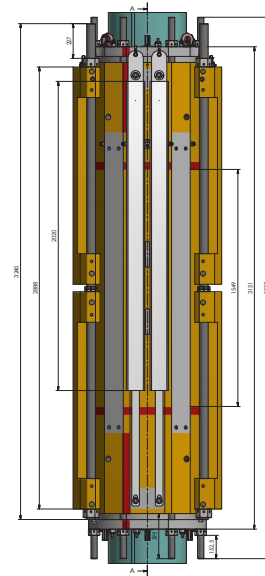
Conductor Repair Clamp Illustrative example

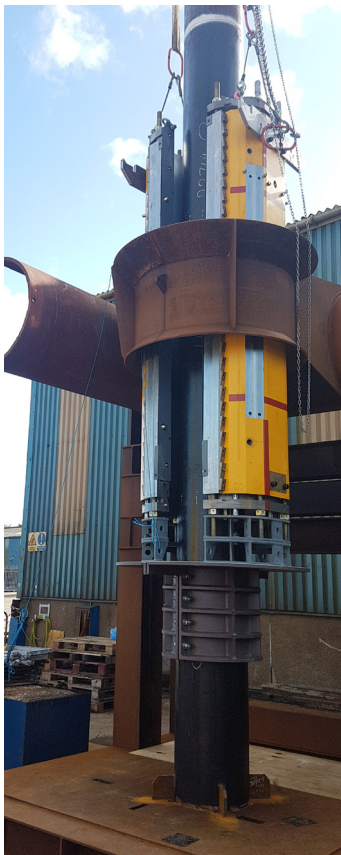
02 // Conductor clamp system integration test assembly

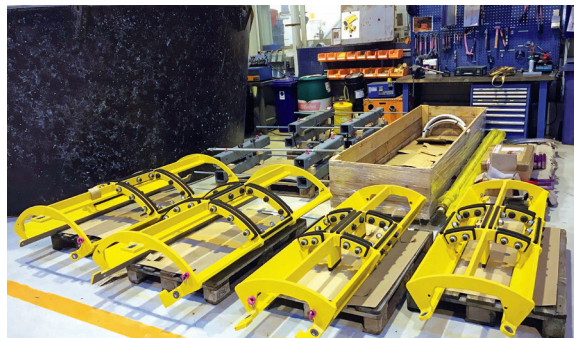
03 // Conductor centralizer fitted to clamp upon successful installation

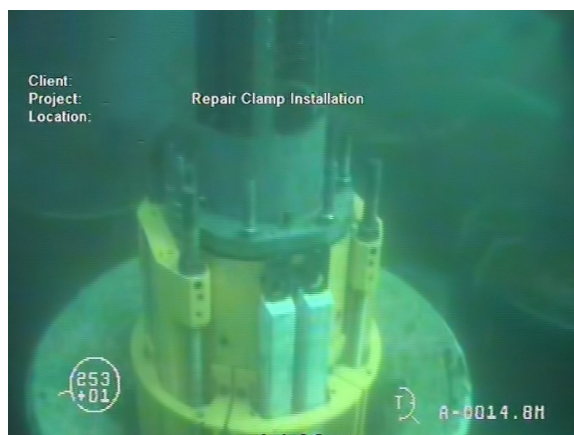
04 // Conductor repair clamp installed

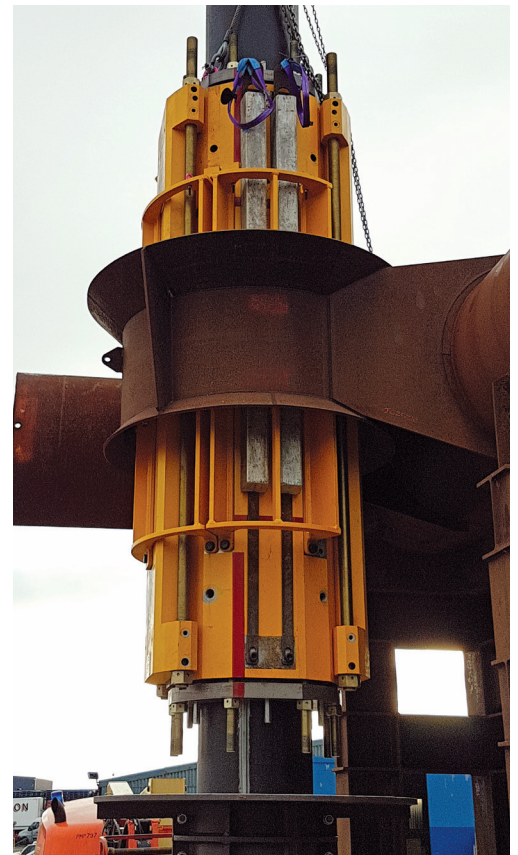
05 // Conductor clamp system integration test complete
